## Test Report

No. SZXEC2201188213

Sample Name : XLPO wire halogen-free

Model No. : UL3173 20AWG Brown

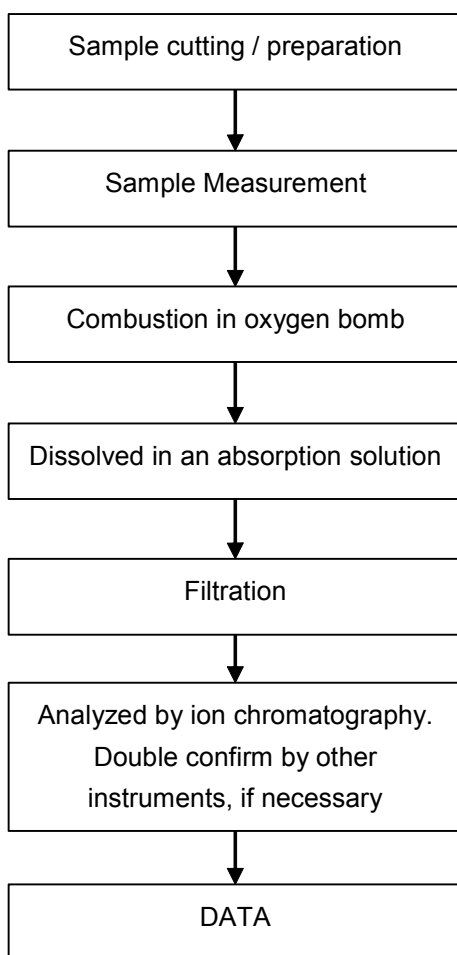
## Halogen Testing Flow Chart

Test Method : With reference to EN 14582:2016, analysis was performed by IC.
